Solution to GV-DVR / VMS LPR's Inability to Identify GV-LPR Capture Dongle

Article ID: GV4-17-01-26-a
Release Date: 02/02/2017

GV-LPR Capture Dongle

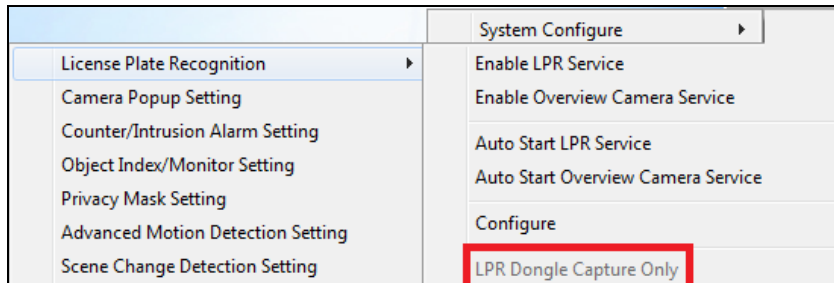
If your GV-LPR Capture Dongle is not properly identified, you will see **LPR Dongle Capture Only** as displayed below.

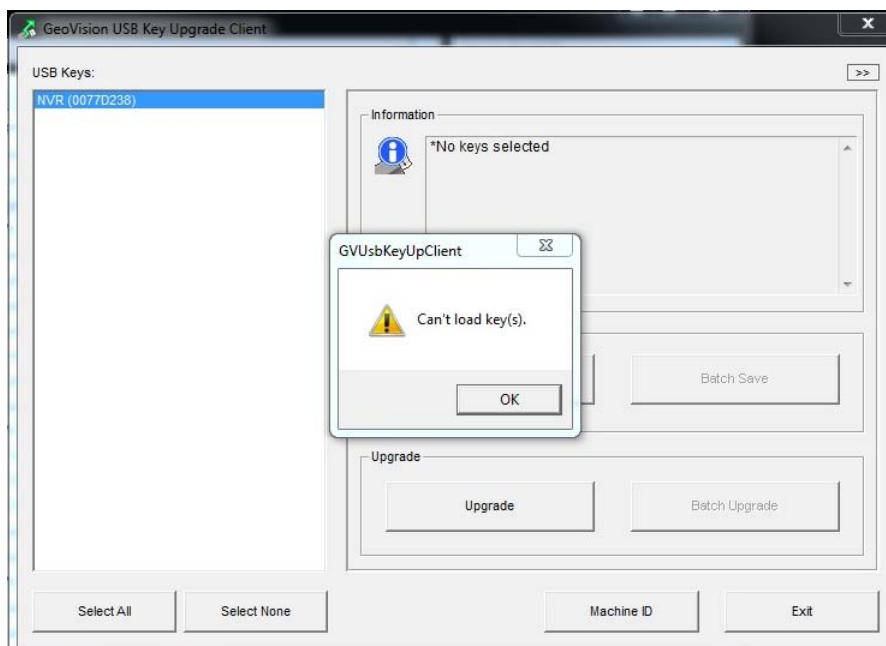
Run **GVUsbKeyUpClient.exe** in your GV-DVR / VMS folder and select the USB key you are checking. The pop-up message **Can't load key(s)** signifies the abnormality of your dongle.

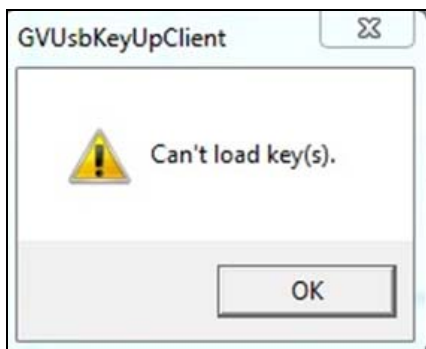
1. Run the new **GVUsbKeyUpClient.exe** (V1.4.7.1) and select the USB key.
 - If the message **Can't load key(s)** remains, please contact your sales representative for RMA process.

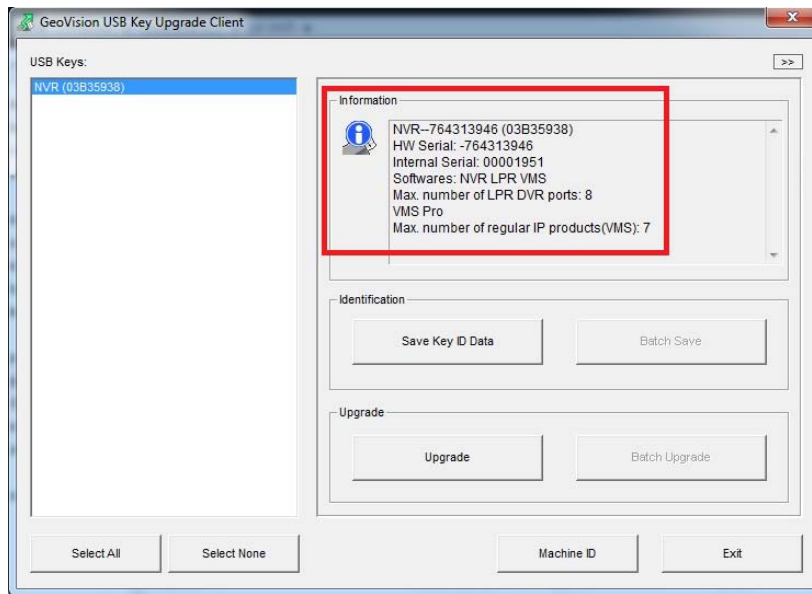
- If the property of the USB key is shown, it indicates that you can proceed with the following solution to fix the problem.
