Problems with GV-AS / EV Controllers After Upgrading Firmware

Article ID: GV4-15-06-04-t

Release Date: 06/04/2015

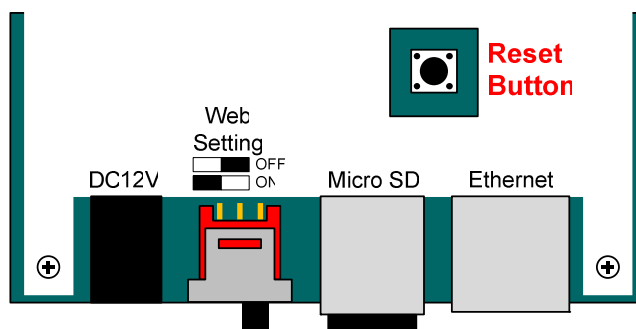
The GV-AS / EV Controllers listed above may not run properly after upgrading to newer firmware. If you are unable to detect the controller in GV-IP Device Utility or GV-Net Module Utility, try restoring the GV-AS / EV Controllers to default settings first. If the problem persists, follow the instructions below to resolve the issue.

1. Remove the seal on the SD card of the GV-AS / EV Controller, and remove the SD card.
2. Press the **Reset** button on the GV-AS / EV Controller for 3 seconds. The location of the Reset button varies among different controller models.
