Solution to GV-DVR / VMS LPR's Inability to Identify GV-LPR Capture Dongle

Article ID: GV4-17-01-26-a
Release Date: 02/02/2017

GV-LPR Capture Dongle

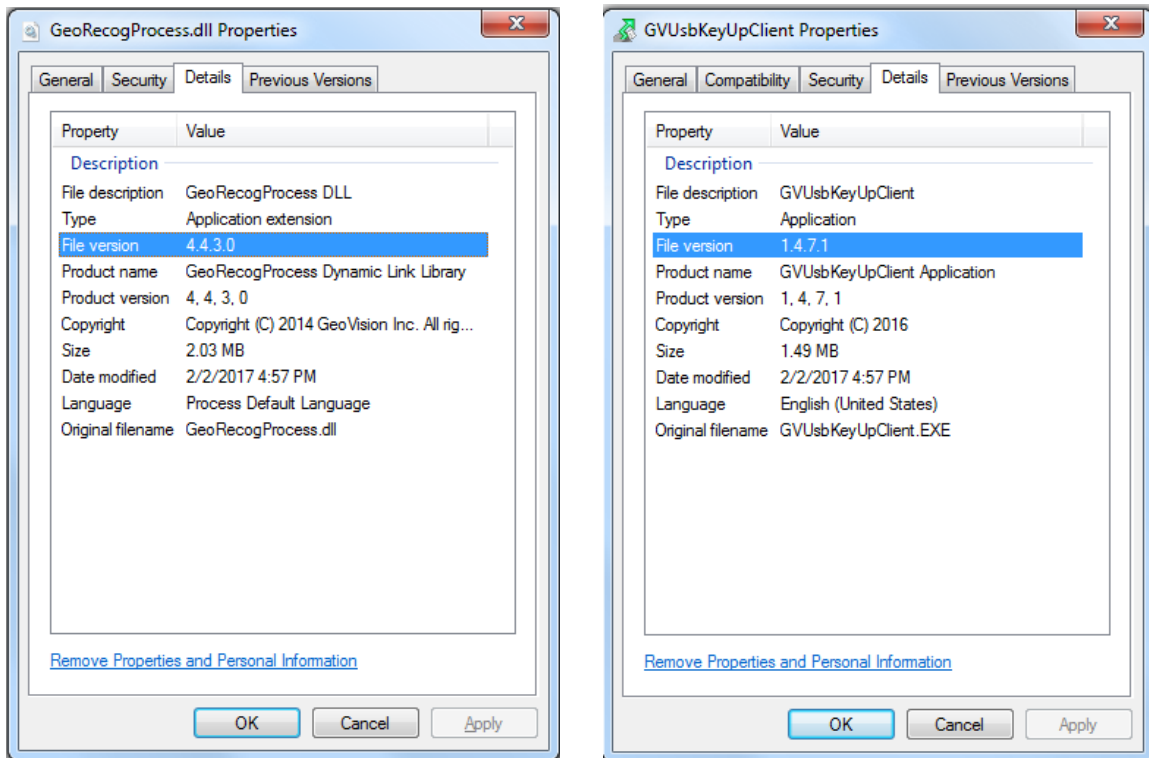
Note: To get the version number of **GVUsbKeyUpClient.exe** (V1.4.7.1) and **GeoRecogProcess.dll** (V4.4.3.0), right-click the file, select **Properties** and select **Details**.
